Erosion and Failure of the Tibial Post after Posterior-stabilized Total Knee Replacement: A Case Report

Introduction: Posterior-stabilized (PS) total knee arthroplasty (TKA) prostheses are characterized by an articulation between the polyethylene tibial post and the cam of the femoral component. Tibial post-fractures, traumatic and non-traumatic, are uncommon but catastrophic complications. We report a rare and unusual case of complete atraumatic erosion of the tibial post after PS-TKA.

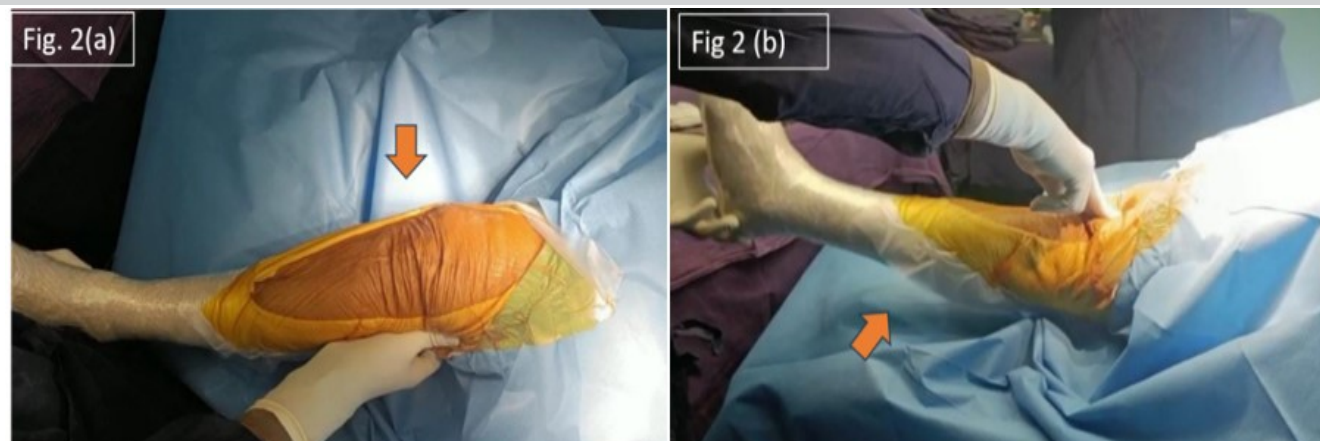
Figure 2: (a and b) Sagittal and coronal plane instability.

Revision surgery was carried out using a standard medial parapatellar approach. Before beginning the revision procedure, the knee recurvatum and valgus opening were assessed and demonstrated intraoperatively (Fig. 2a and b). After the completion of the arthrotomy, the polyethylene tibial post was missing and was not located within the knee joint cavity (Fig. 3a). There were no signs of infection. The polyethylene insert was removed and noted to have evidence of polyethylene wear, with clear evidence of delamination and striping in the location of the tibial post. (Fig. 3b) both the femoral and tibial components were well fixed, and the surgeon tried to address the instability with a thicker insert (17 mm maximum PS insert available). However, the knee was still lax, with an incompetent MCL. Subsequently, the decision was taken to proceed with a complete revision arthroplasty with a rotating hinge prosthesis. The surgeon implanted the DePuy (DePuy Synthes, J and J, Warsaw, USA) Noiles rotating hinge knee. The trial hinge components gave the surgeon good biplanar stability and knee ROM. The components were cemented and tourniquet deflated. The immediate post-operative X-ray is shown in (Fig. 4).

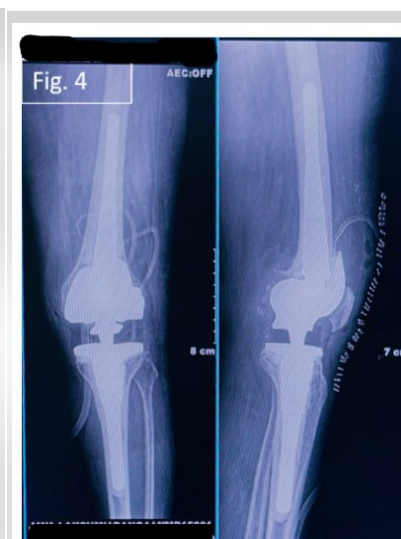
Figure 4: Immediate post-operative radiograph following revision surgery.
